Trip Report 2001 Annual Inspection of the Parkersburg, West Virginia, Nuclear Waste Policy Act Section 151(c) Disposal Site

Summary

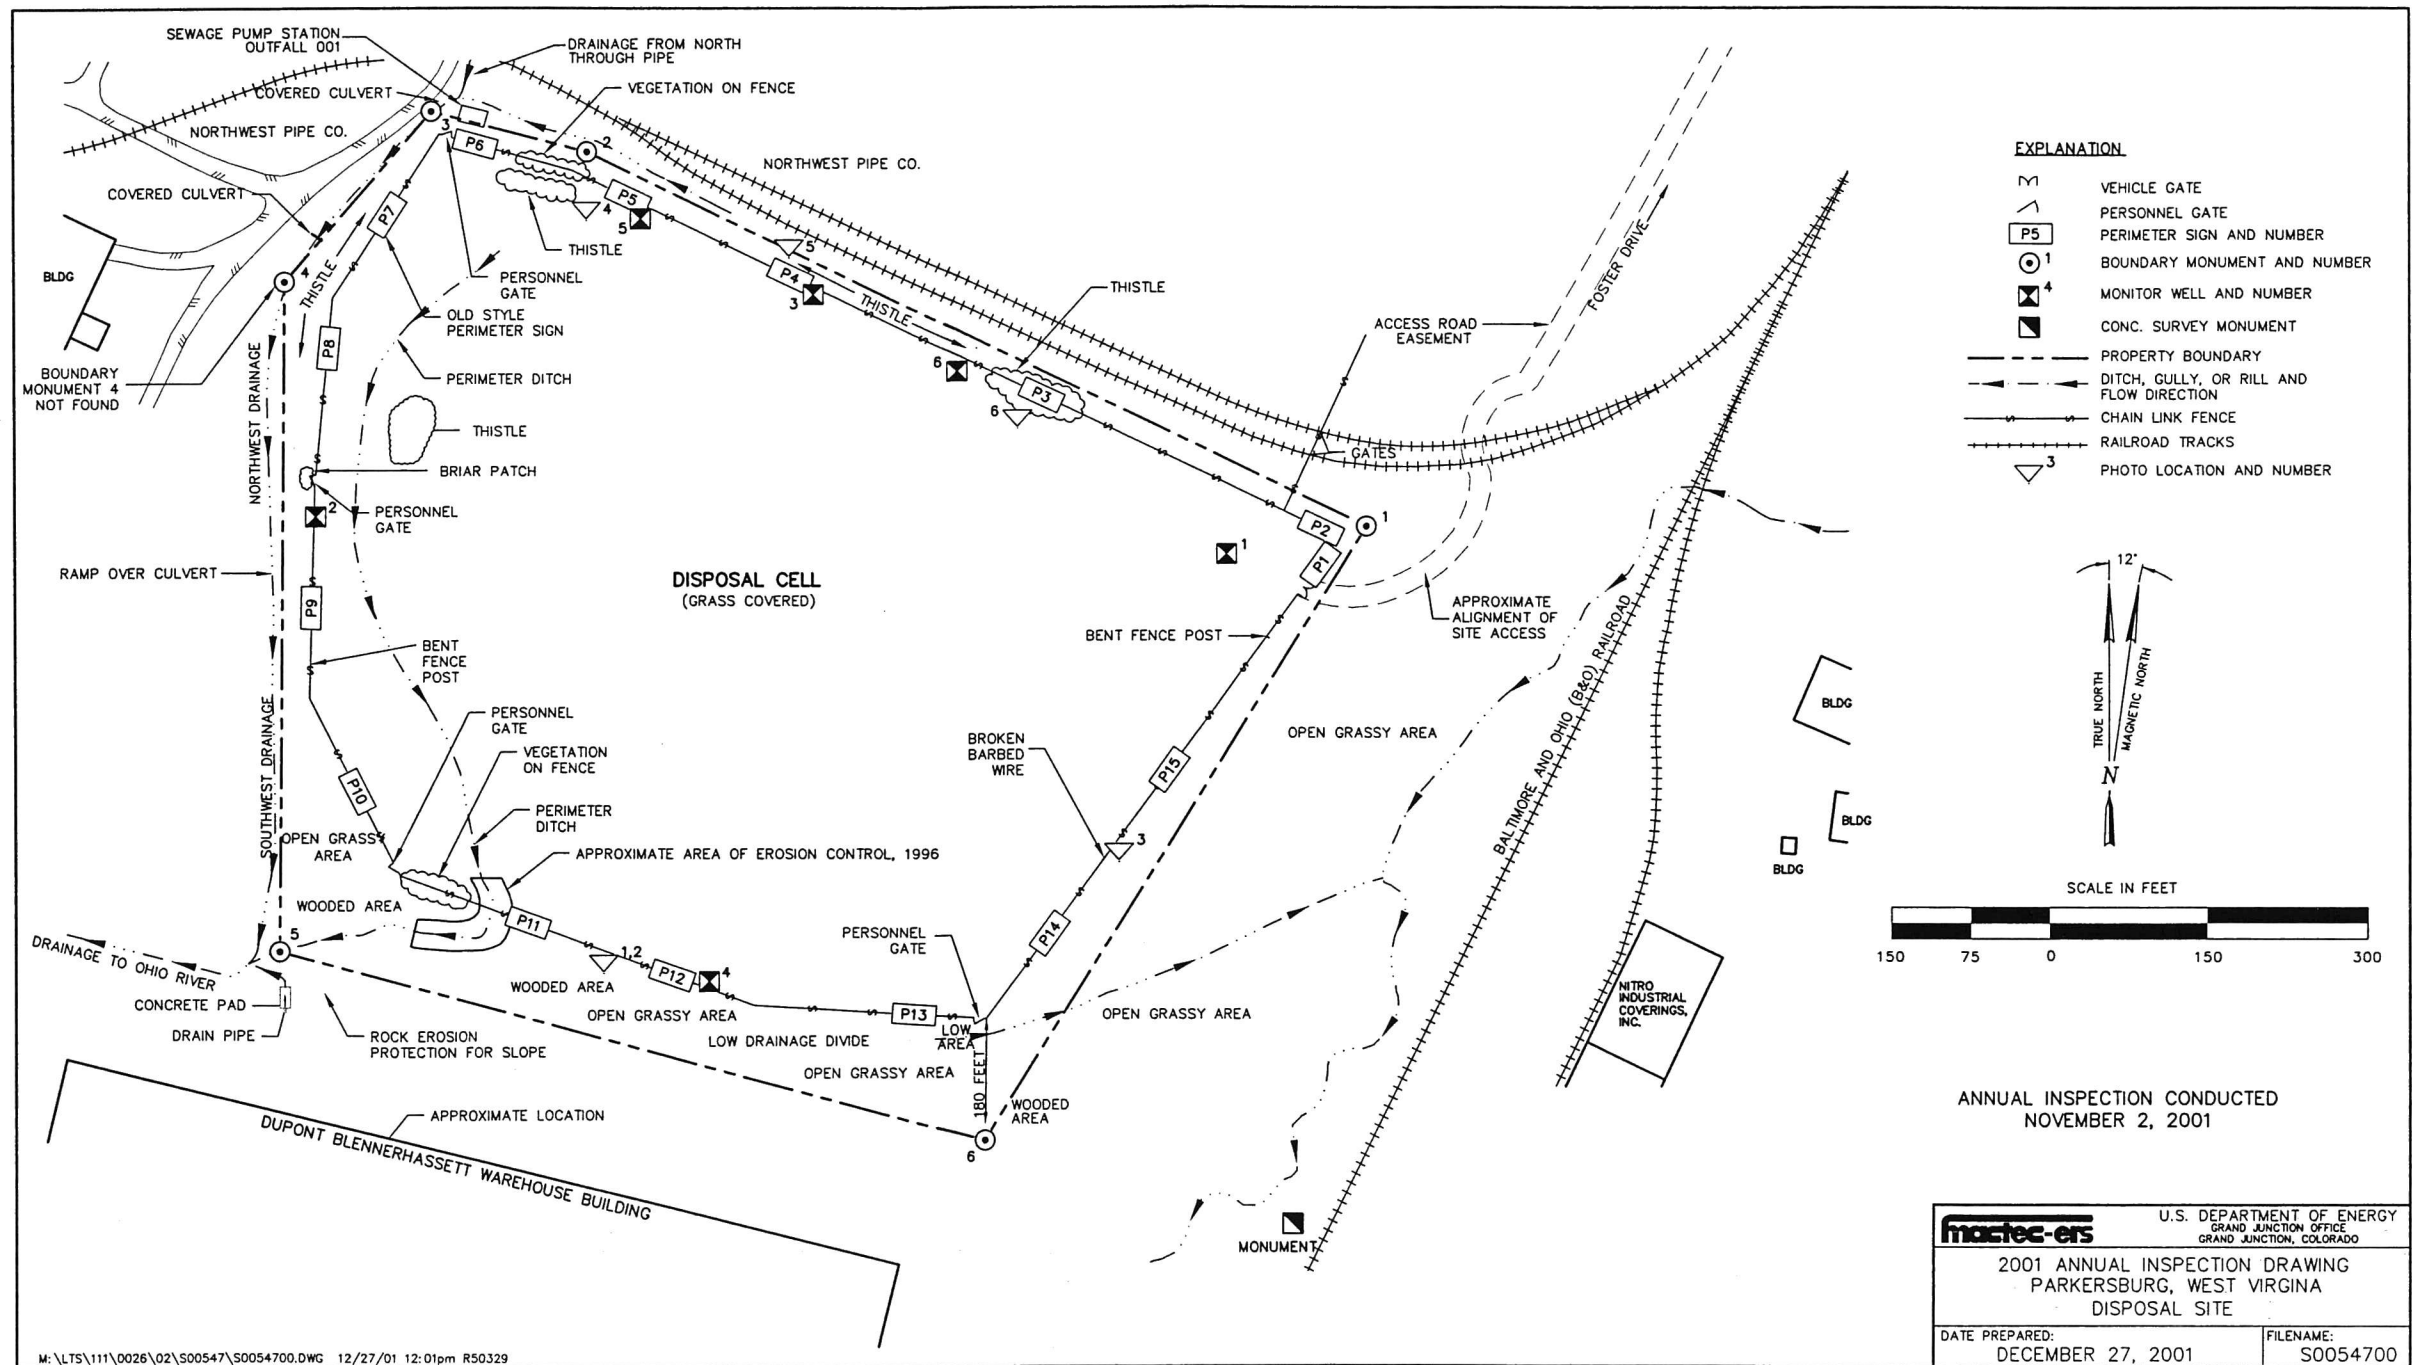
PL 5. Patch of thistle near perimeter sign P3.

Recommendation: These patches of thistle should be specifically targeted for spraying during the 2002 maintenance season.
